ECBP APPENDIX B
Action Plan to Address Erosional Outfalls

ACTION PLAN TO ADDRESS EROSIONAL OUTFALLS

US ARMY GARRISON, HAWAII
SEPTEMBER 2014

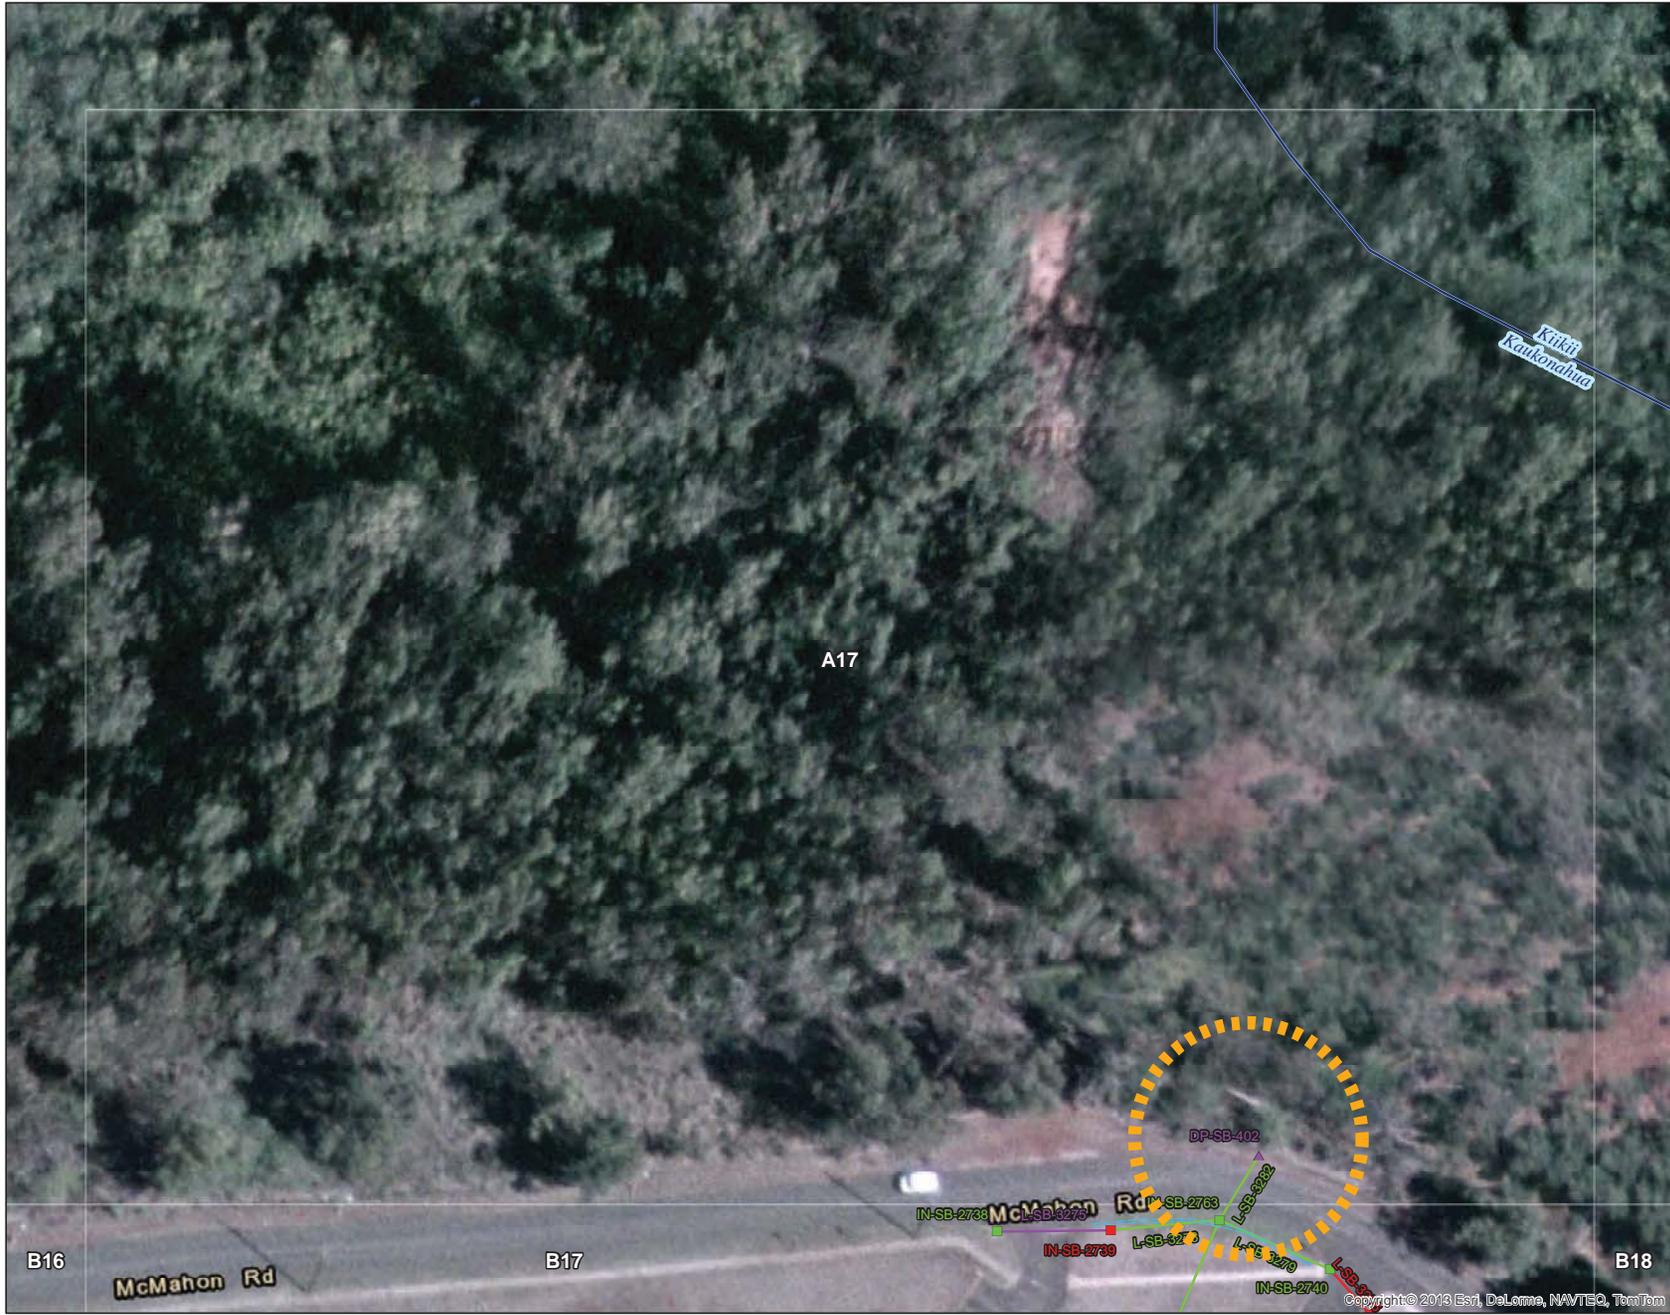
ID DP-SB-402

Access Unable_To_Access

Access Note Fence

Other Note Outfall not found.
Research location of outfall.

Maintenance Action Locate, clear, and temporarily remediate.

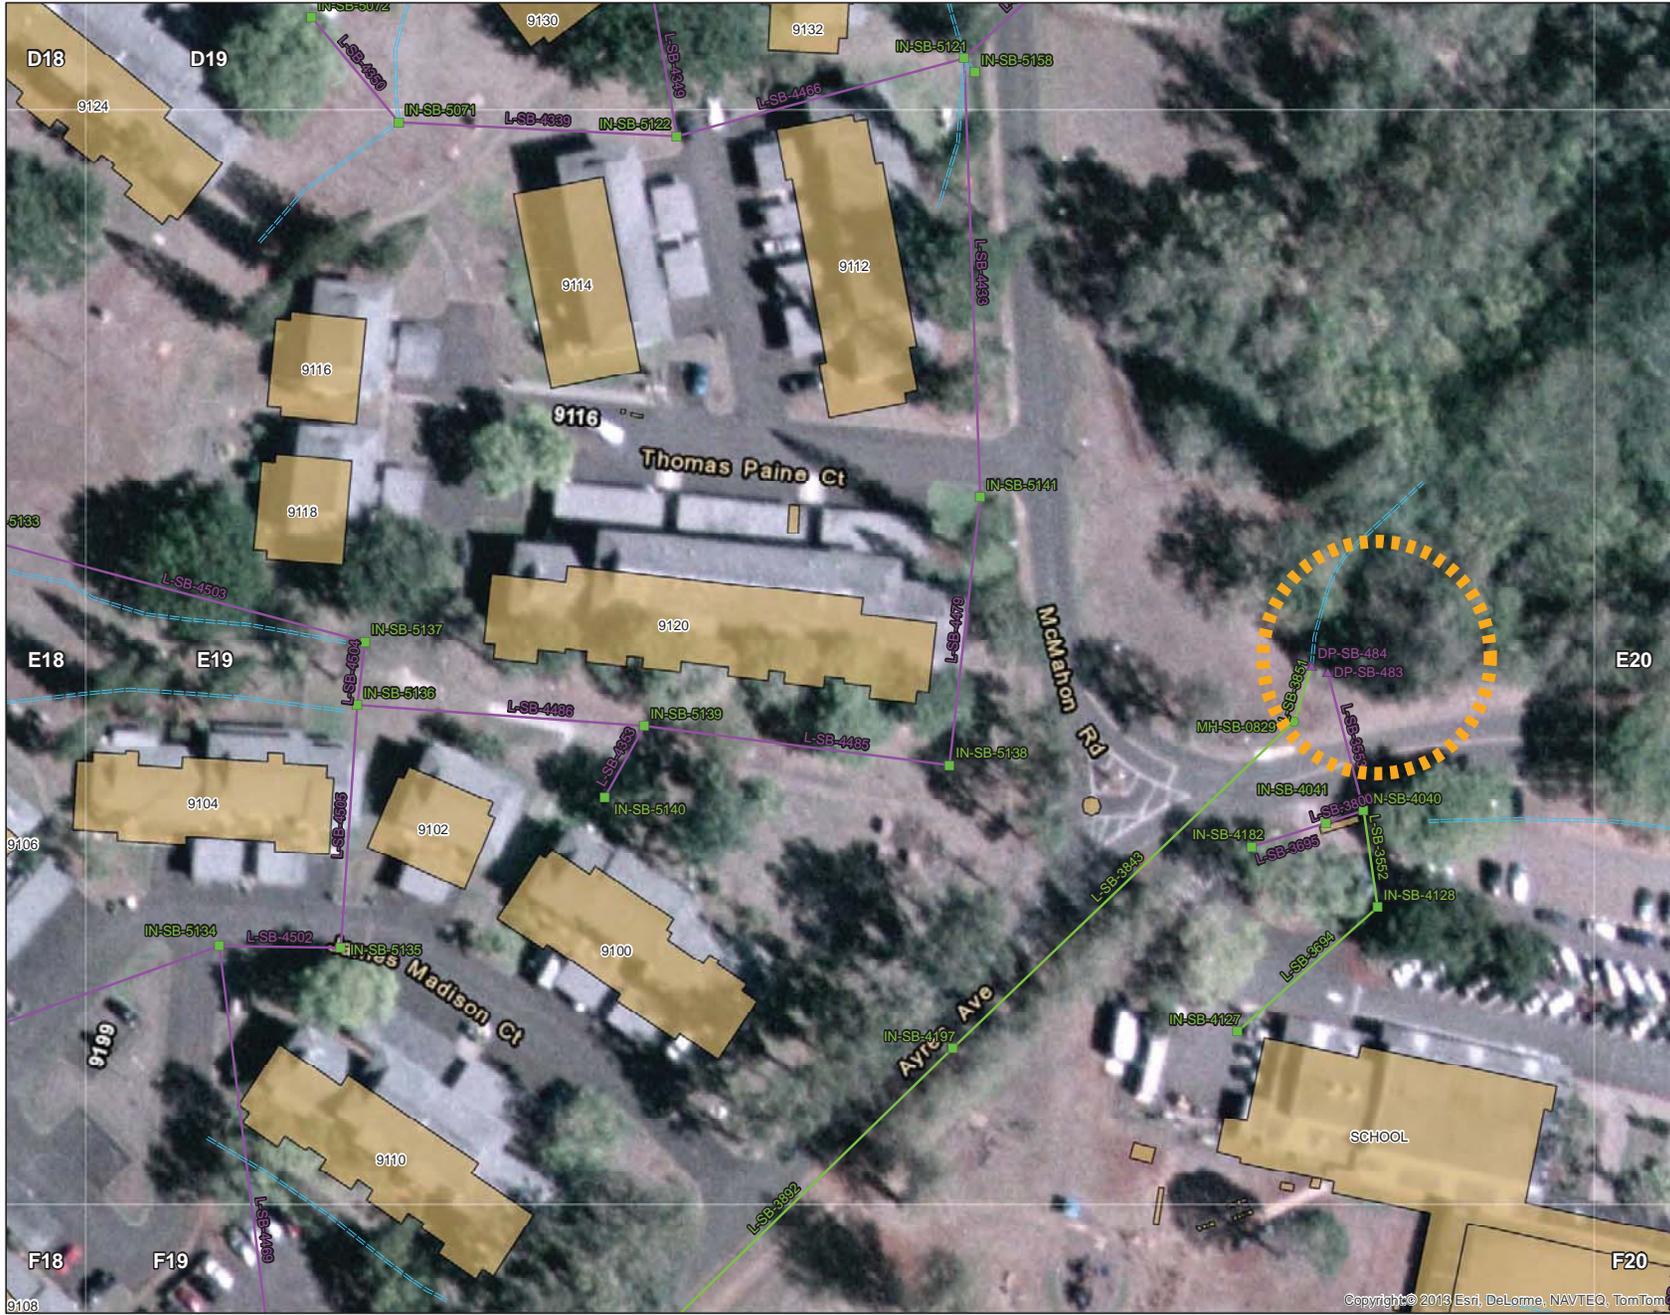
ID DP-SB-483

Access Unable_To_Access

Access Note Fenced

Other Note Outfall not found.
Research location of outfall.

Maintenance Action Locate, clear, and temporarily remediate.

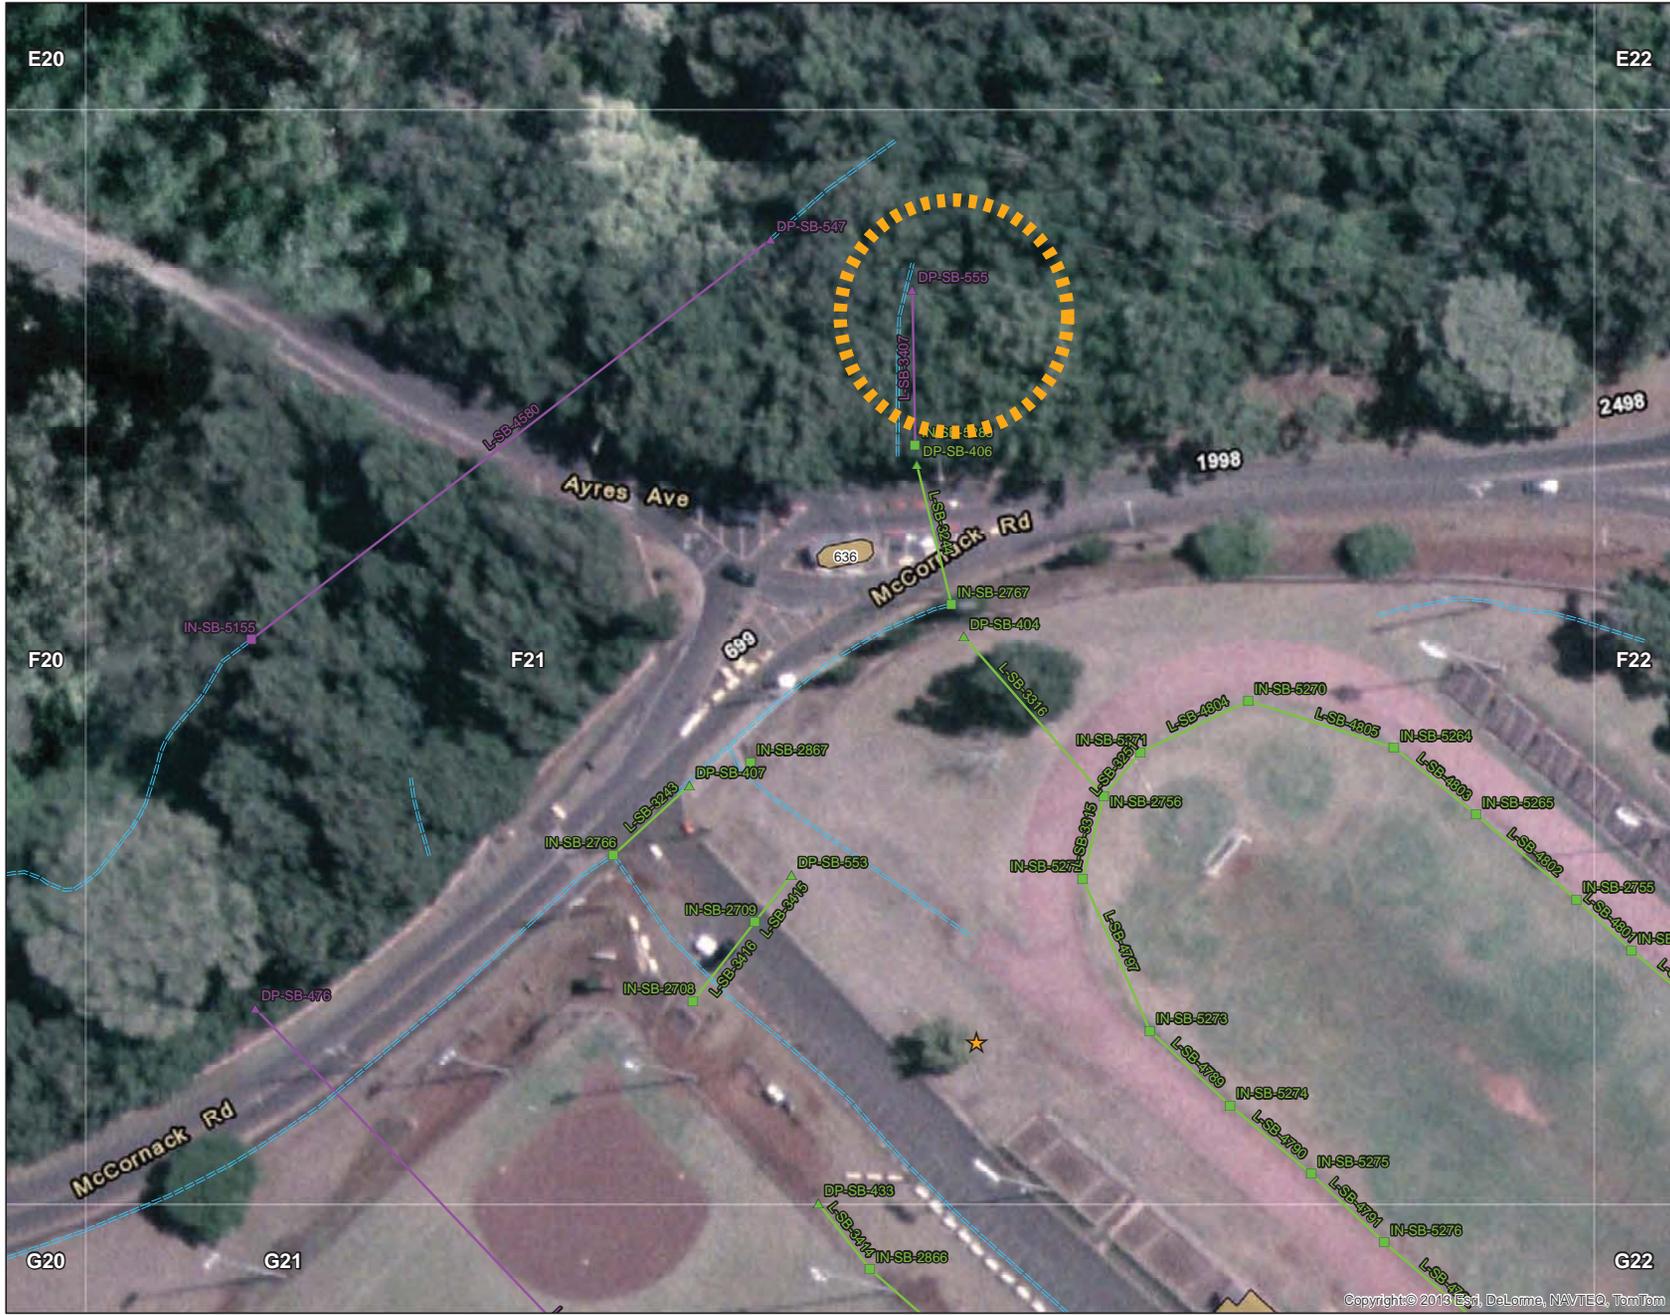
ID DP-SB-555

Access Unable_To_Access

Access Note Fence, terrain

Other Note Outfall not found.
Research location of
outfall.

Maintenance Action **Locate, clear, and temporarily remediate.**

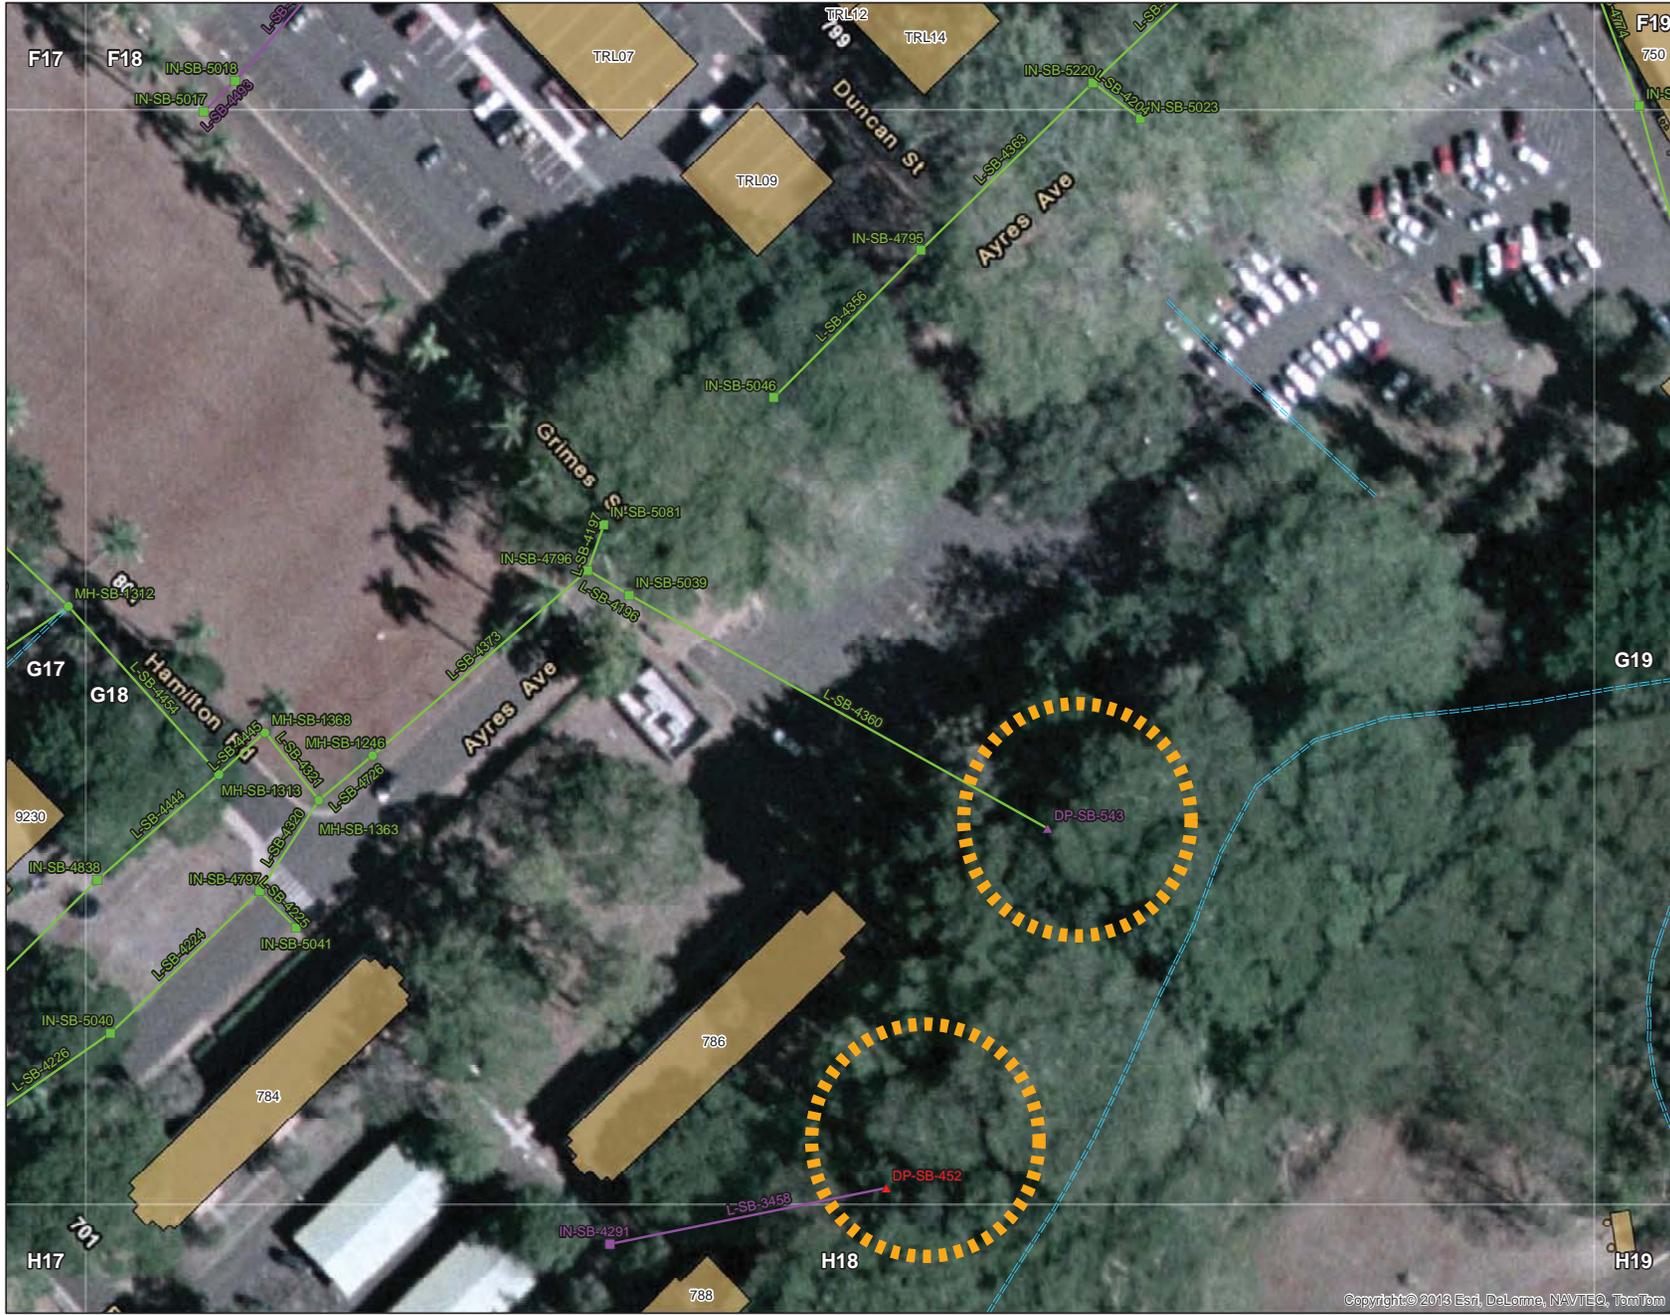
ID DP-SB-452

Access OTHER

Access Note Terrain, no access

Other Note Outfall not found.
Research location of outfall.

Maintenance Action Locate, clear, and temporarily remediate.
