HAZARD COMMUNICATION

USAG-HI

Asbestos, Lead-Based Paint and Canec

February 2014

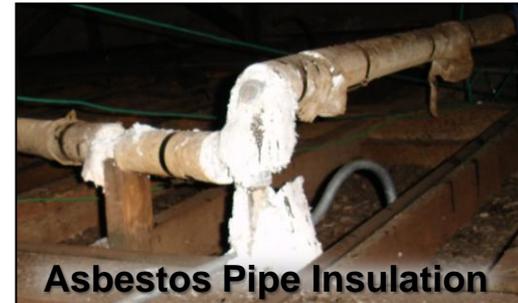
Asbestos Pipe Insulation

- **Asbestos can be present in:** Vinyl sheet flooring; vinyl floor tiles; asphalt floor tiles; flooring backing; roofing shingles; cement wallboard; acoustical plaster; decorative plaster; boiler insulation; electrical wiring insulation; electrical panel partitions; caulking; spackling; adhesives; chalkboards; cement siding; cement pipes; heating and electrical ducts; fire blankets; fire doors; high temperature gaskets; brake shoes; elevator equipment panels; ceiling tiles; electrical cloth; and thermal paper products.

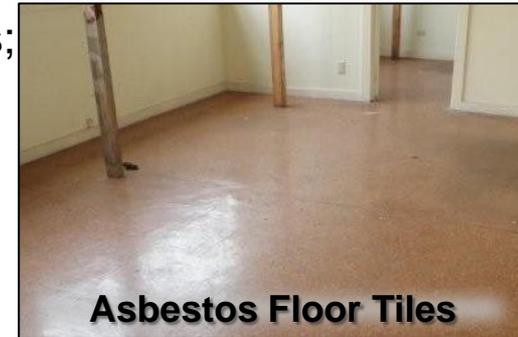
Asbestos Floor Tiles

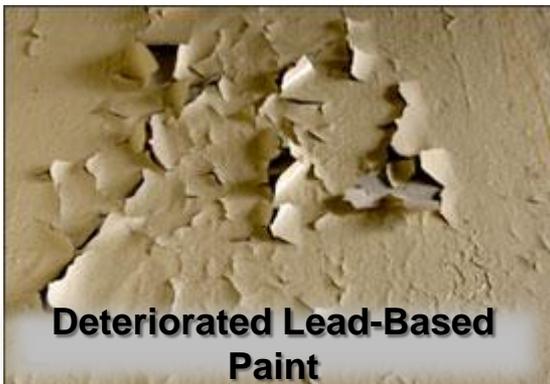
Deteriorated Lead-Based Paint

- **Lead-Based Paint:** Is commonly found inside and outside USAG-HI facilities on painted surfaces, road surface markings, construction products and demolition debris.

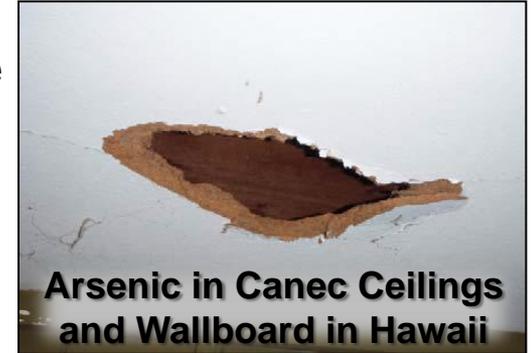
- **Canec:** Is the common name for a fiberboard building material that was treated with inorganic **arsenic compounds** as an anti-termite agent in the early 1930 to 1964. Canec was used for interior ceilings and walls in many residential and commercial structures throughout the State of Hawaii. The material itself is a fiberboard that is brownish-orange in color, though the exposed surface is typically finished smooth and painted, making it look similar to modern drywalls.
